Geotechnical Engineering Failures and Lessons Learned

JAMES W. NIEHOFF, PE

SENIOR GEOTECHNICAL ENGINEER

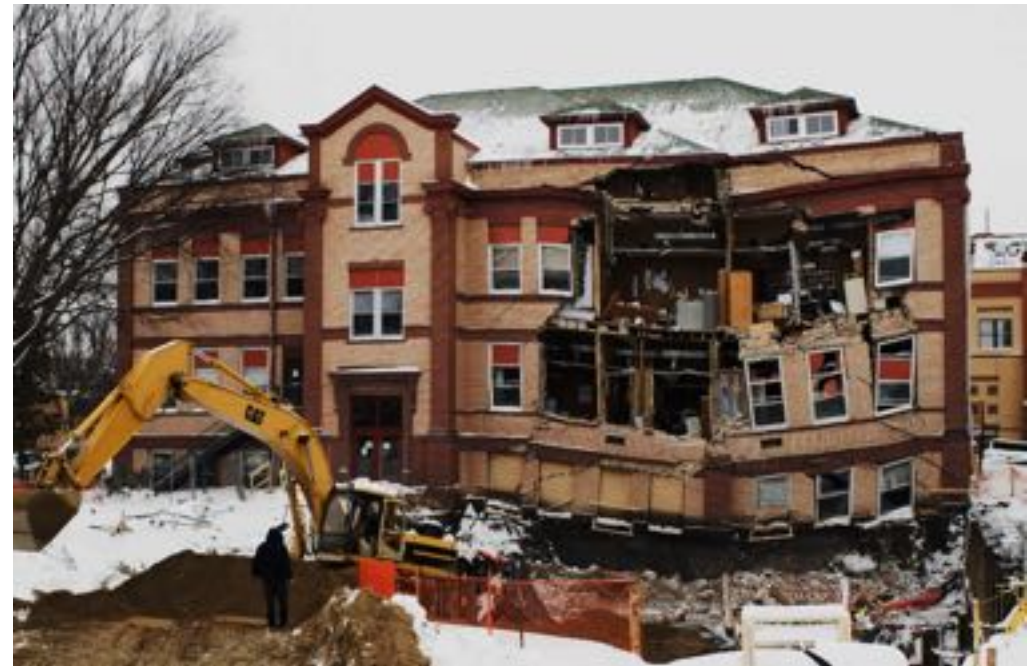
Building Collapse

- ▶ Collapse of 1929 section of building shortly after midnight on December 27, 2009.
- ▶ No one injured.

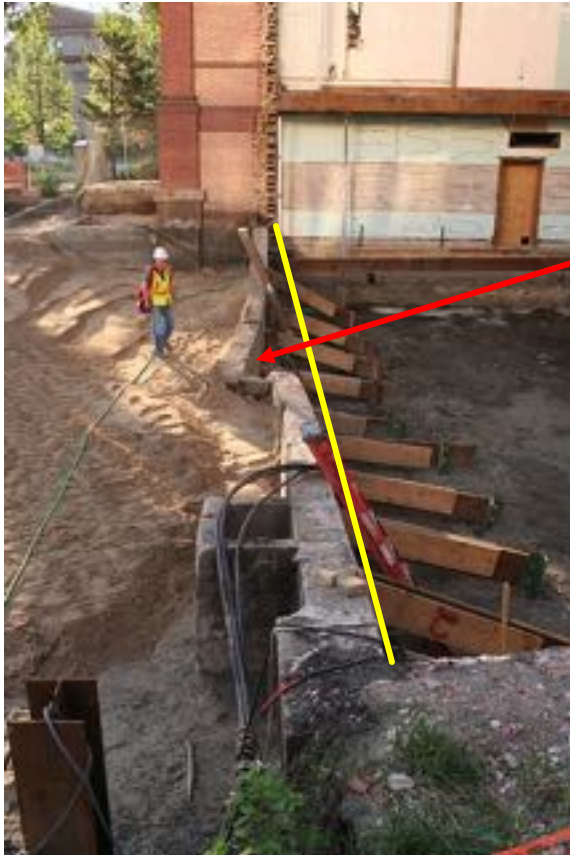
Displacement of Foundation Wall – Predominantly Lateral

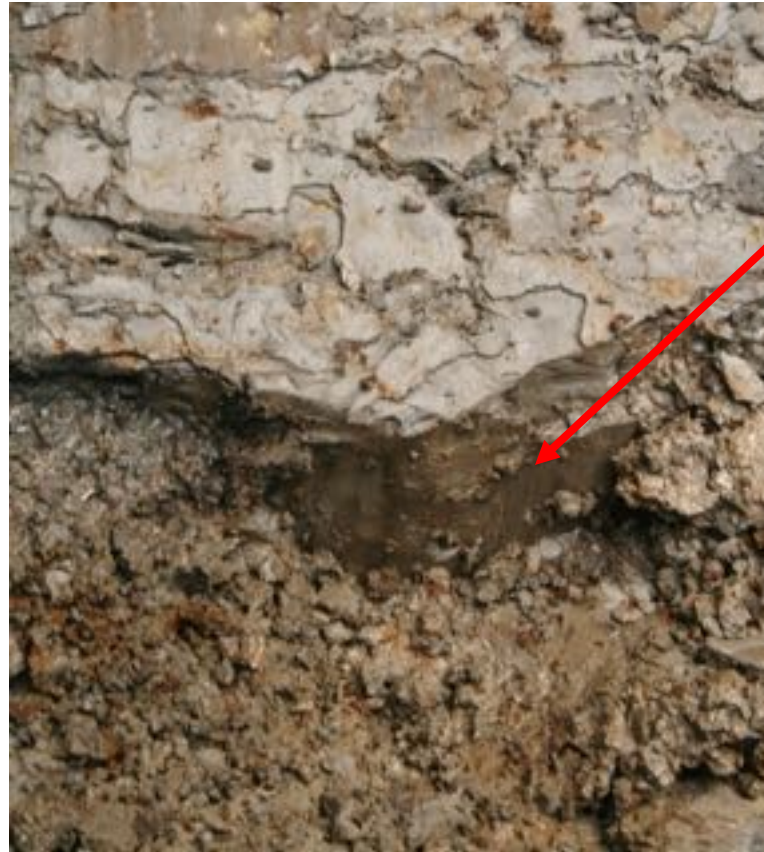
Failure Surface in Clay Below Footing

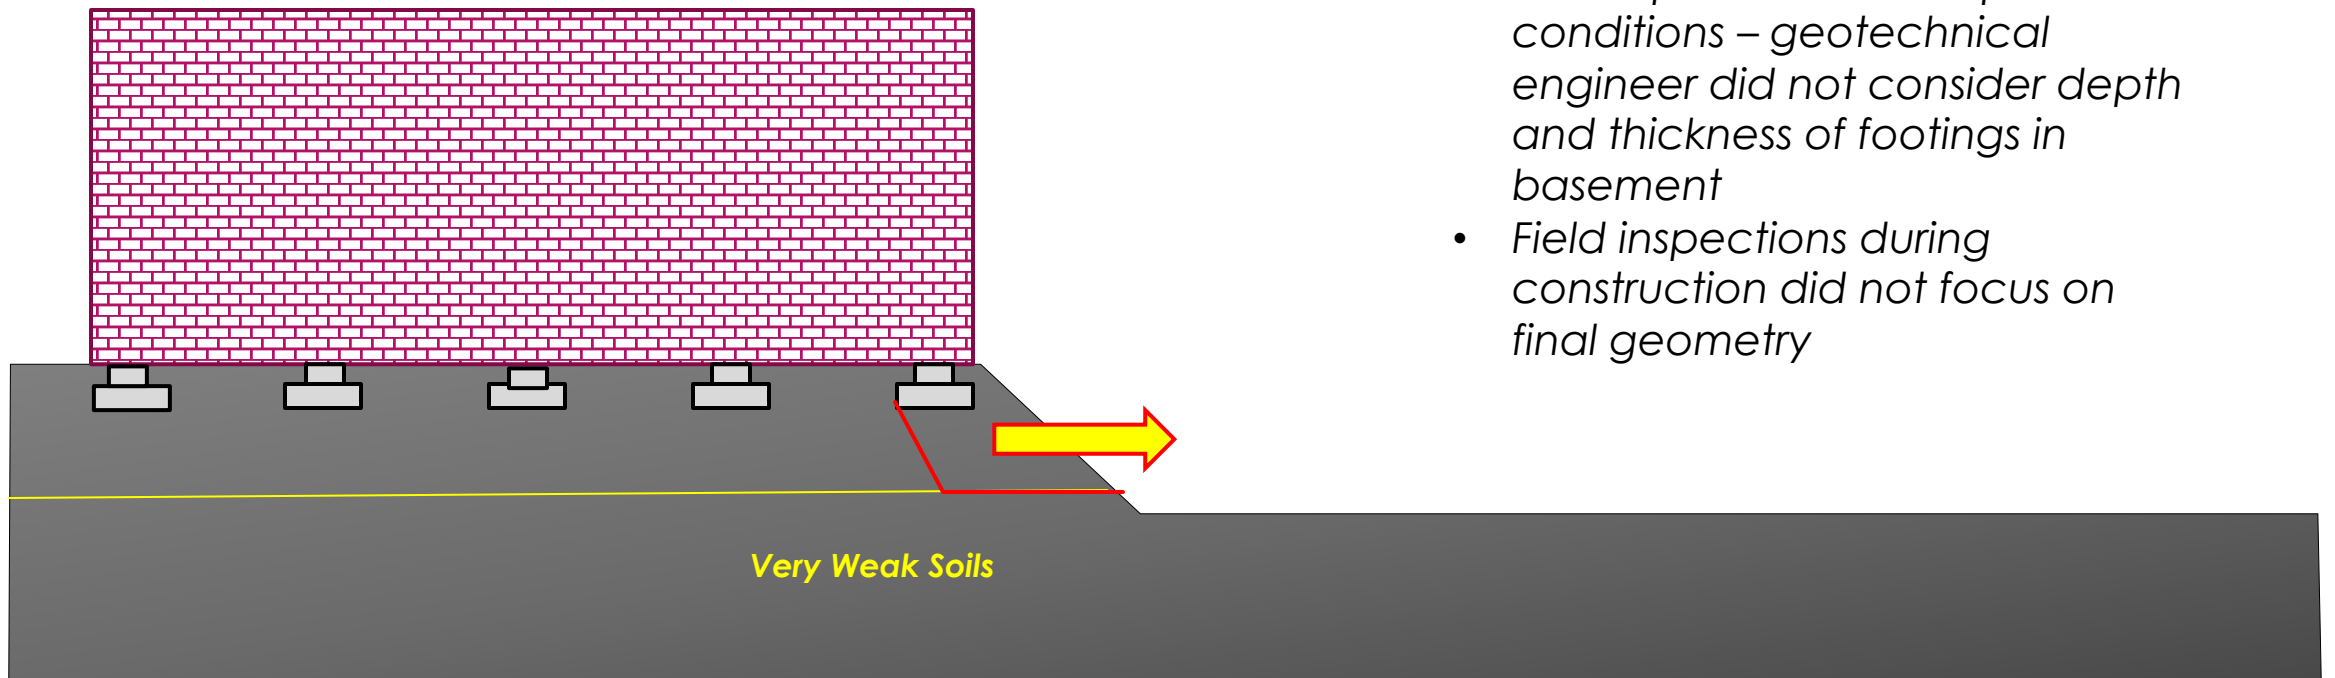
Conclusions

- Cut slope was too steep for conditions – geotechnical engineer did not consider depth and thickness of footings in basement
- Field inspections during construction did not focus on final geometry

- ▶ Consider final configuration of cut slopes
- ▶ Be conservative in selection of material properties – use lower bound strengths, when consequences of failure are high
- ▶ Use excavation bracing systems to protect critical structures – this is not the best place to save on construction costs
- ▶ Install monitoring devices and take readings frequently during construction

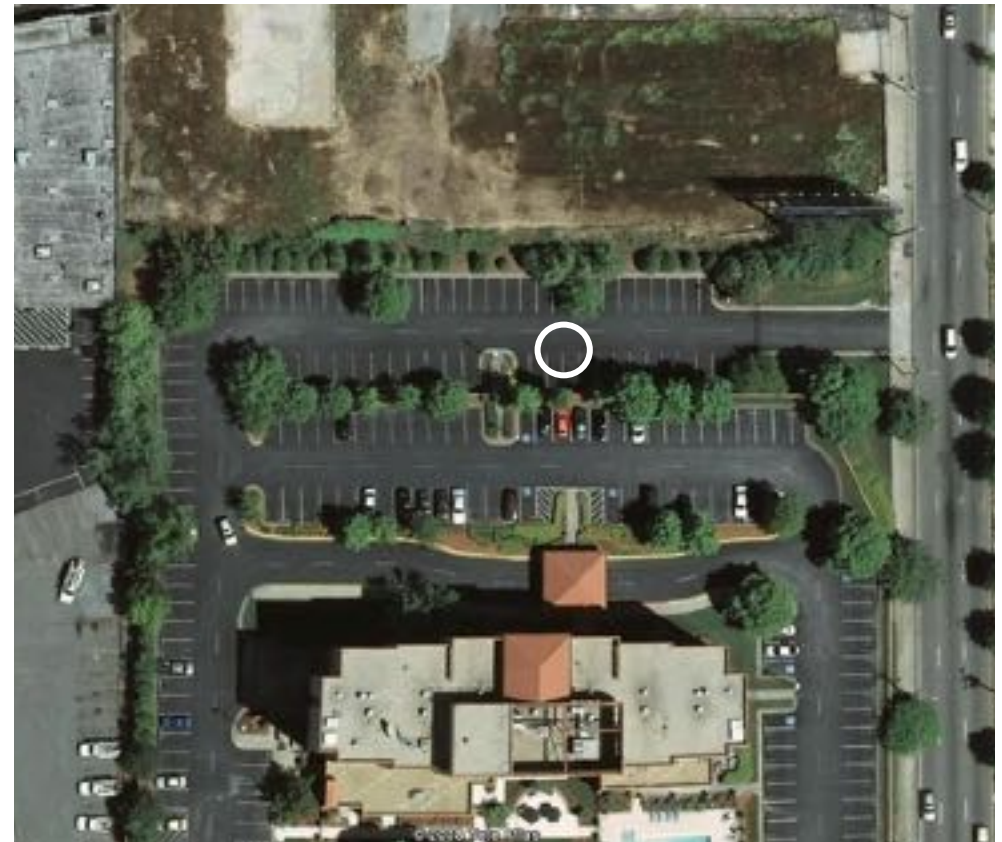
- ▶ A depression was noted in the parking lot near a storm sewer manhole in mid-June 1993
- ▶ Small area roped off to protect public
- ▶ Studies of the cause of the depression were planned and scheduled

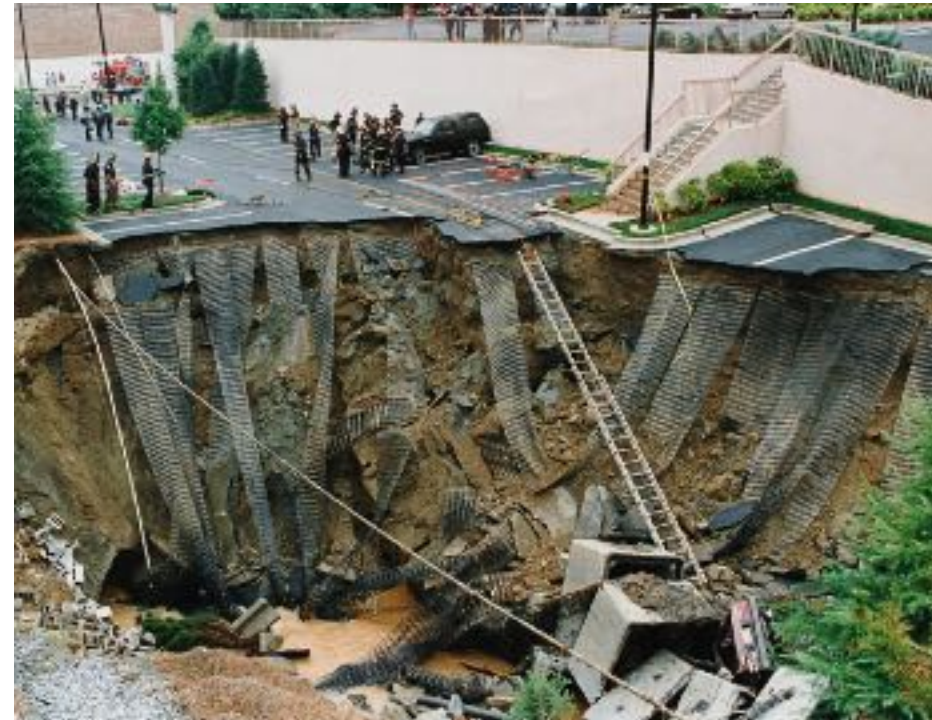
- ▶ The next day on June 14th, Atlanta experienced a 50-year storm event
- ▶ The depression in the parking lot widened and a large puddle formed causing a car to stall when entering parking lot
- ▶ The car's driver entered the hotel and requested assistance from an employee.
- ▶ Upon reaching the car, a sinkhole nearly 200 feet in diameter dropped out, swallowing both individuals and three cars.

- ▶ Communication failed at several points:
 - ▶ Developer did not inform operator of the presence of geogrid or its purpose
 - ▶ Inspector did not communicate extent or urgency of the problem to the hotel operator
- ▶ In some instances, mitigation techniques can mask a problem and increase the consequences of failure

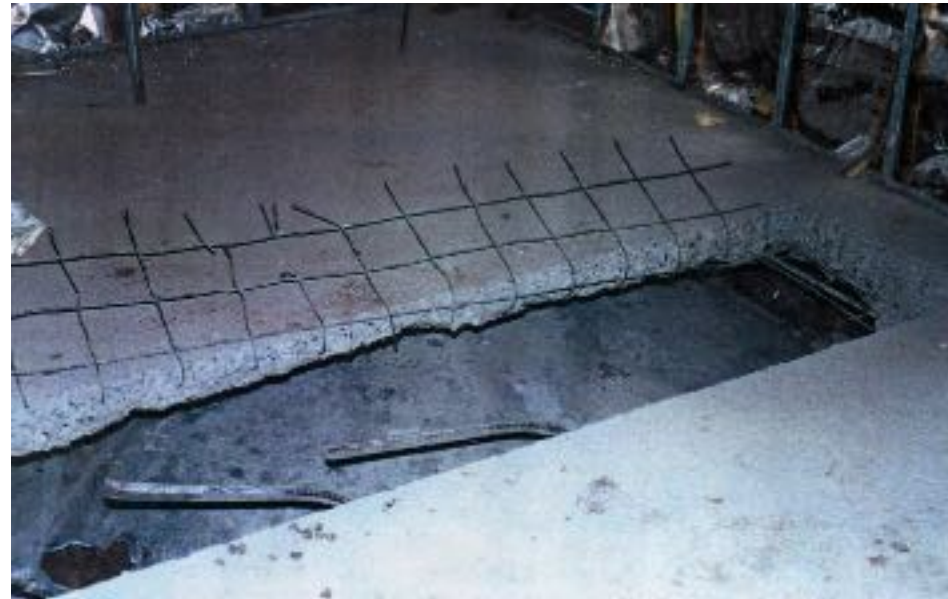
- ▶ Within 2 months of opening, slab on grade floors sagged and sounded hollow in public areas of the hotel
- ▶ Voids up to 12 inches in height found under slab “on grade” floors

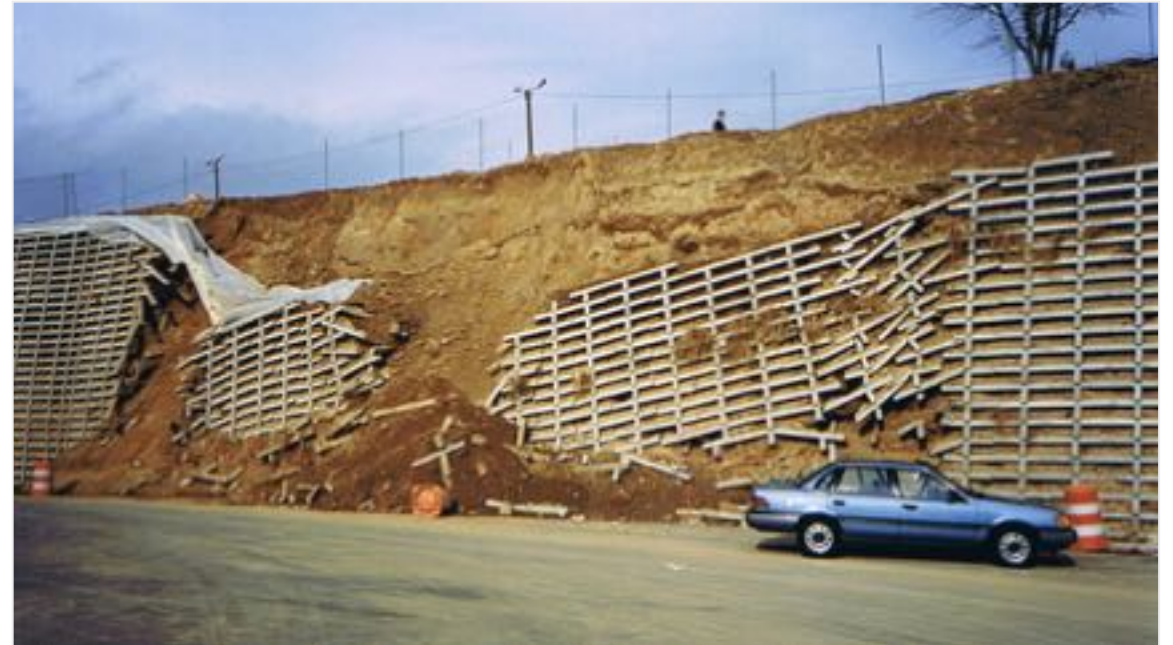
Crib Wall Failure

- ▶ Within 6 months of construction, crib wall failed
- ▶ Threatened parking lot of adjacent shopping center

- ▶ Walls over 25 feet in height were found to settle differentially leading to a progressive failure over time.
- ▶ More massive walls were required to shift the resultant of pressures to the center of the wall base to avoid differential settlement.

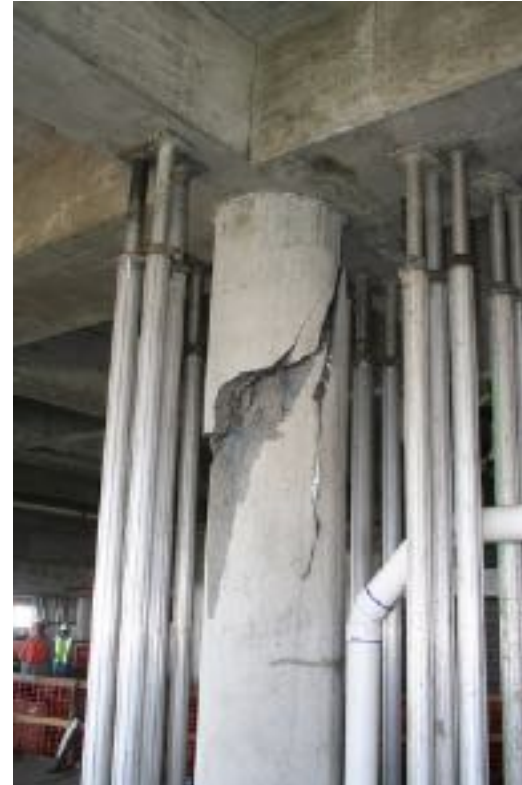
- ▶ 31 story condominium
- ▶ Began to settle significantly when it reached floor 17
- ▶ Over 16 inches of differential settlement caused massive damage to columns and structural frame, particularly at the interface between the high and low-rise sections

- Blow counts in the test borings were not corrected for depth. What appeared to be 24 blow per foot material was closer to 10 blows per foot after correction.
- Design did not consider the group effects of 500 piles under the tower.
- The low and high-rise sections were structurally connected and experienced 16 inches of differential movement over 1 bay.
- While tower settled relatively uniformly, and was structurally sound, it could not be separated from the parking deck due to the post-tensioning cables.

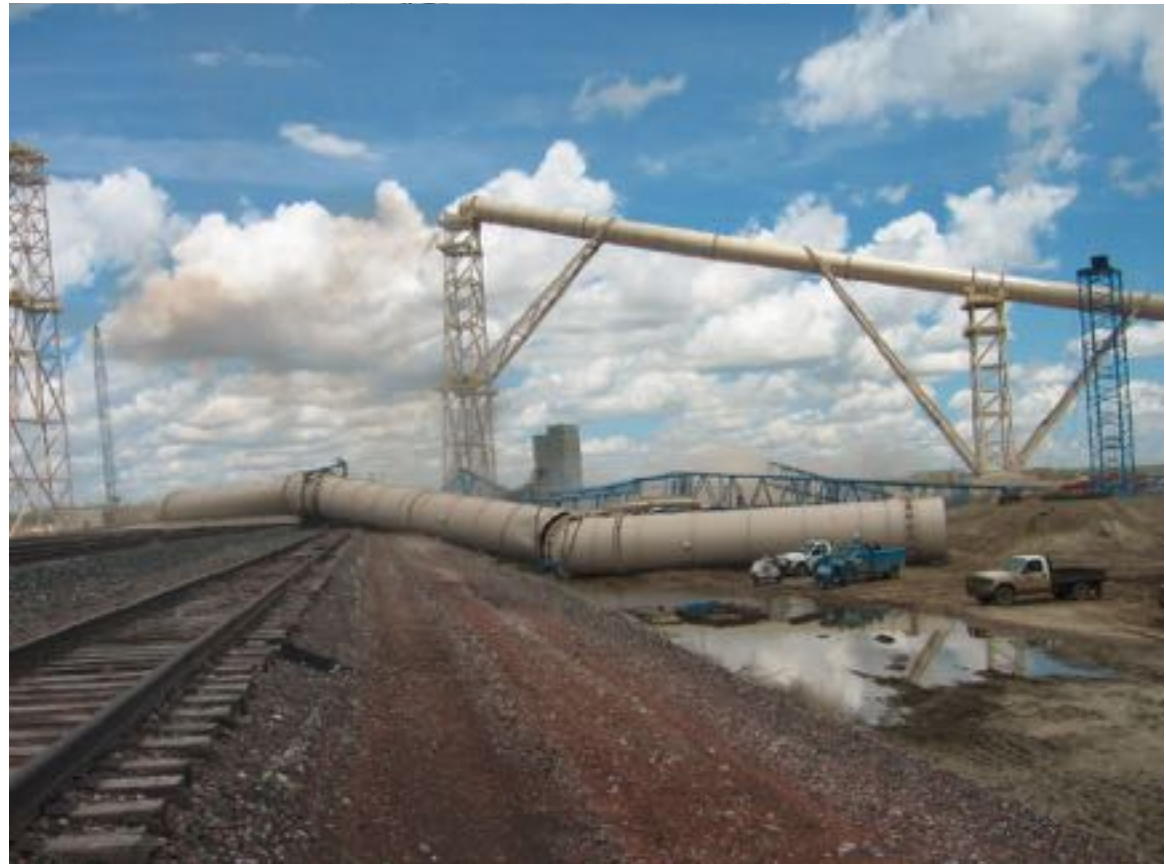
Crane Collapse

- ▶ Crane collapsed while installing a 1/2 million pound section of conveyor system
- ▶ Three workers injured
- ▶ Rail line blocked
- ▶ Total loss of \$3 million crane

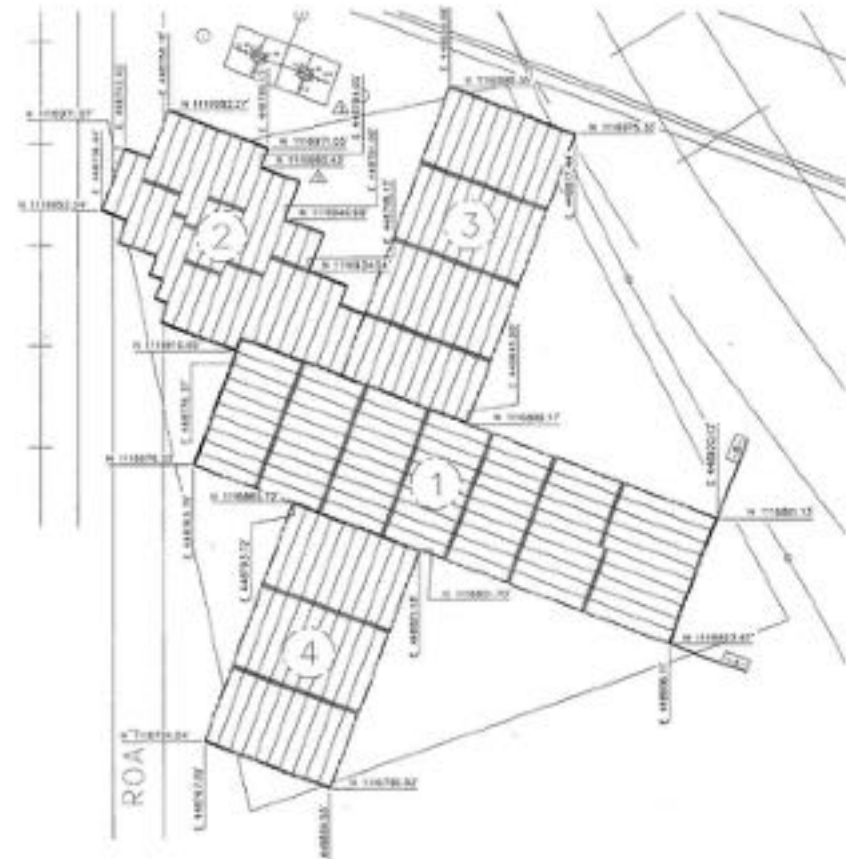
Timber Mat

- ▶ Mat placed on sandy silt soil – subgrade inspected by project geotechnical engineer and judged to be suitable
- ▶ Mat situated in low area between two sets of railroad tracks
- ▶ 4 inches of rain recorded in days leading up to failure – water ponded around timber matting

- ▶ Engineers should consider support capacities of soil under all environmental conditions
- ▶ Contractors should react to obvious and observable changes in conditions and should seek support from qualified engineers

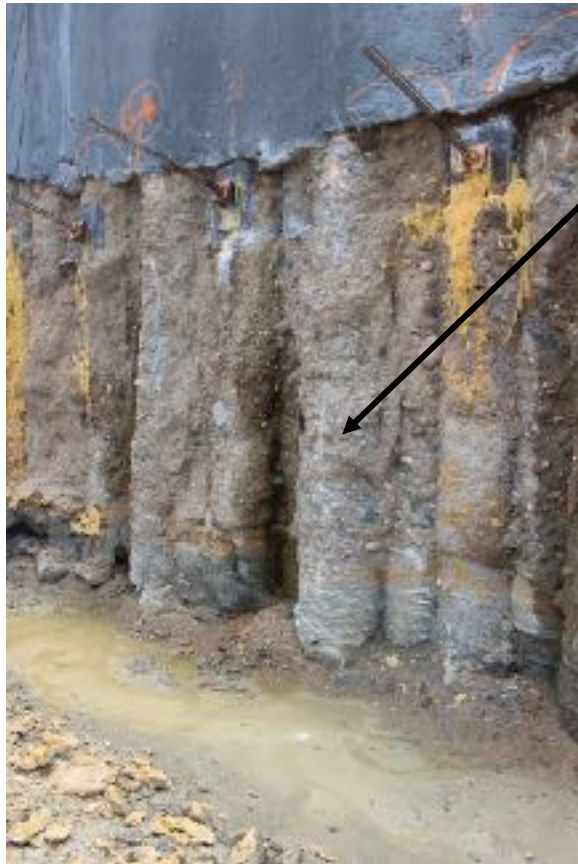
**Misaligned
Piles**

- CFA Rig used multiple flights with non-rigid connections
- Instrumentation in cab only measured inclination of mast, not the auger during drilling

- ▶ Use proper equipment for conditions – cased piers would have been more appropriate for this project
- ▶ In top down construction, it is not always possible to detect problems, even with an experienced inspector

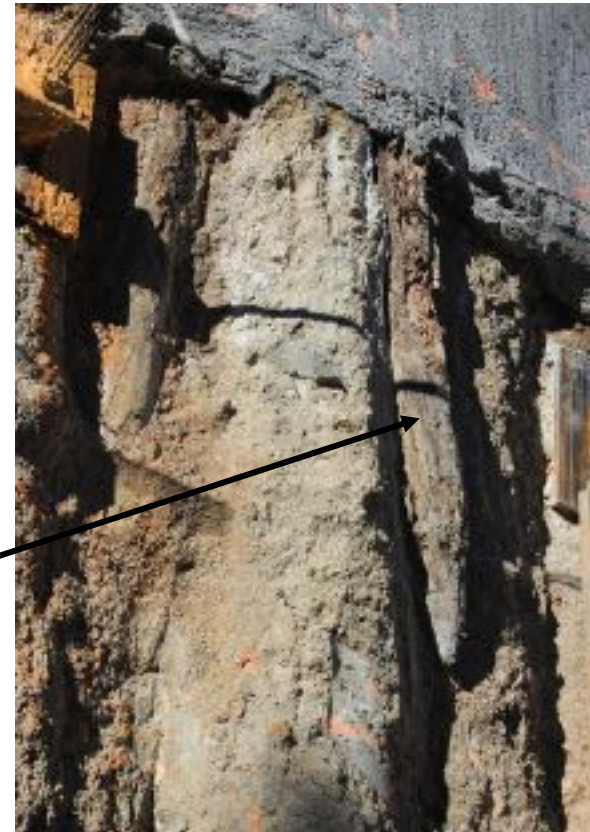
**Old Timber
Piles**

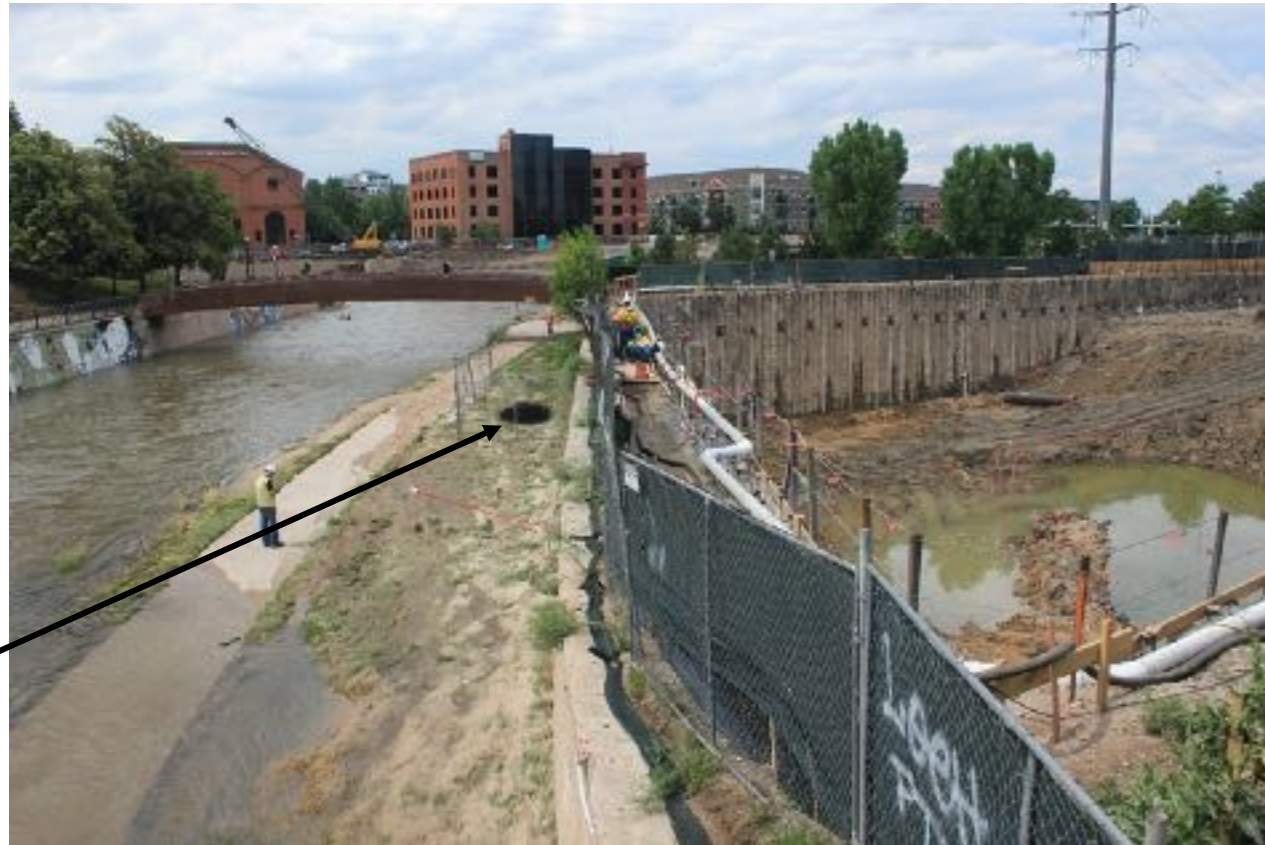
**Sinkhole
Exterior to the
Excavation**
