Geotechnical Engineering Failures and Lessons Learned

JAMES W. NIEHOFF, PE

SENIOR GEOTECHNICAL ENGINEER

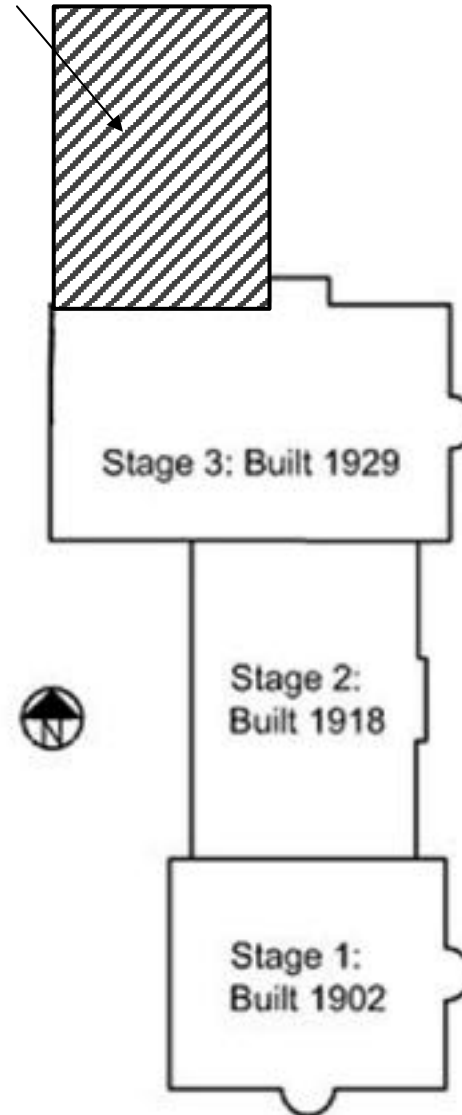
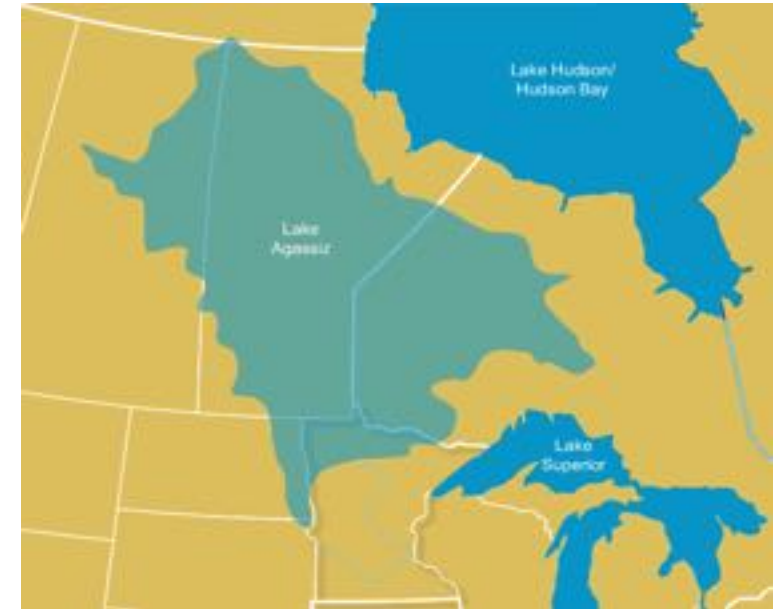
Proposed Addition

- Three levels above grade, two levels below grade
- Existing structure on shallow spread footing foundations close to ground surface
- Subsurface materials – Lake Agassiz clay

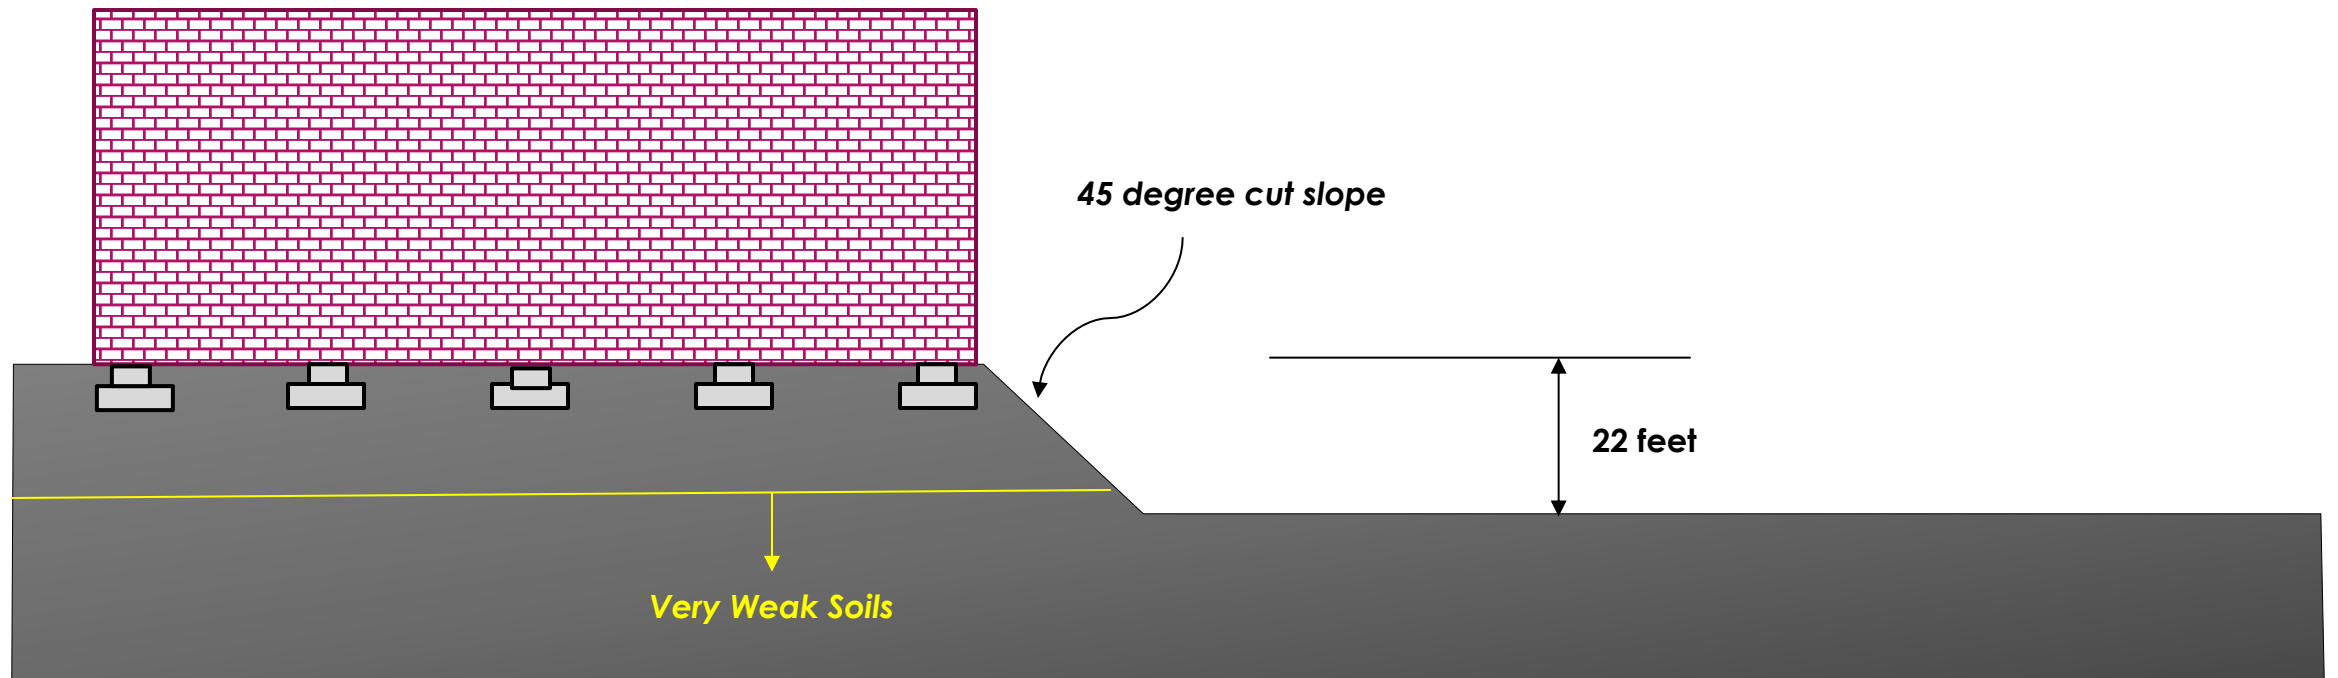
Building Addition

- Cut slope was too steep for conditions – geotechnical engineer did not consider depth and thickness of footings in basement
- Field inspections during construction did not focus on final geometry

- ▶ Consider final configuration of cut slopes
- ▶ Be conservative in selection of material properties – use lower bound strengths, when consequences of failure are high
- ▶ Use excavation bracing systems to protect critical structures – this is not the best place to save on construction costs
- ▶ Install monitoring devices and take readings frequently during construction

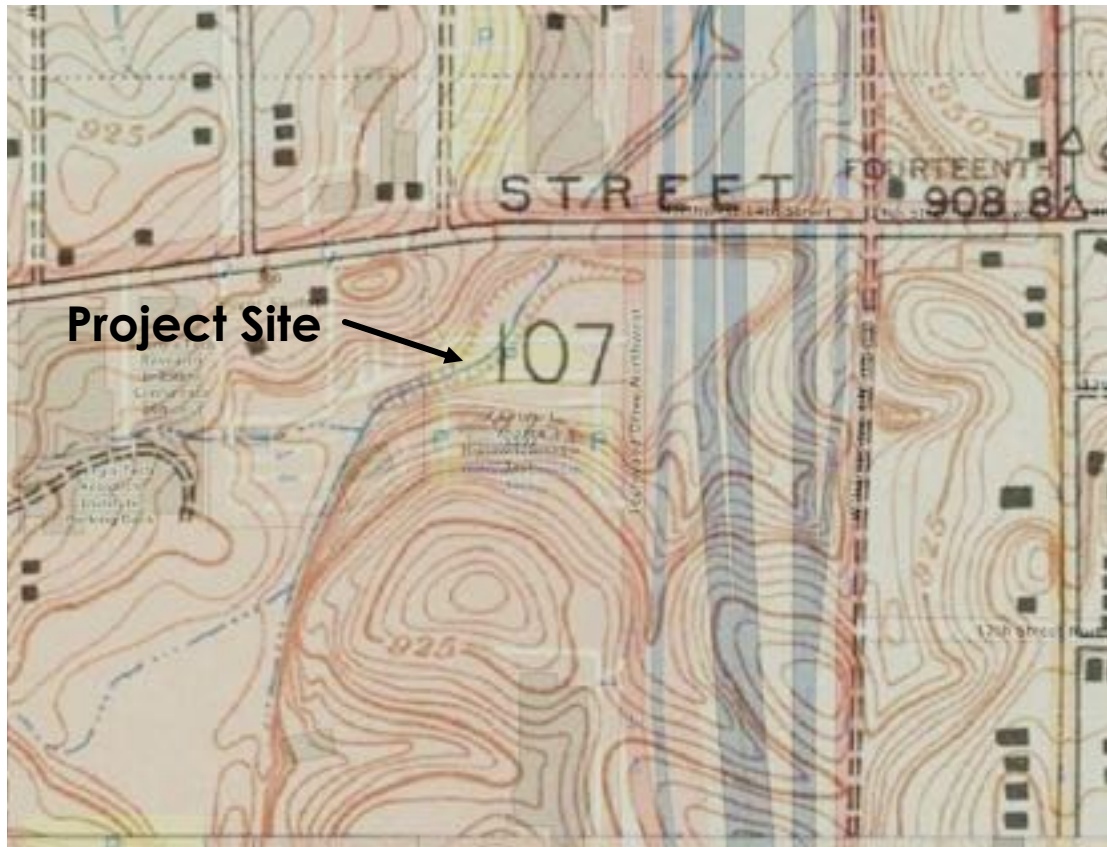
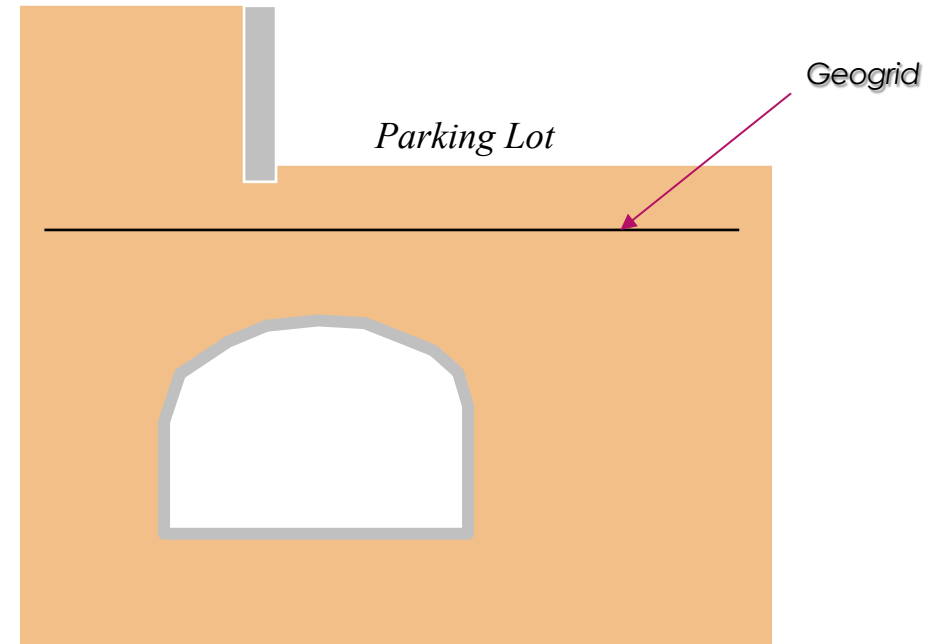
Site History

- ▶ Communication failed at several points:
 - ▶ Developer did not inform operator of the presence of geogrid or its purpose
 - ▶ Inspector did not communicate extent or urgency of the problem to the hotel operator
- ▶ In some instances, mitigation techniques can mask a problem and increase the consequences of failure

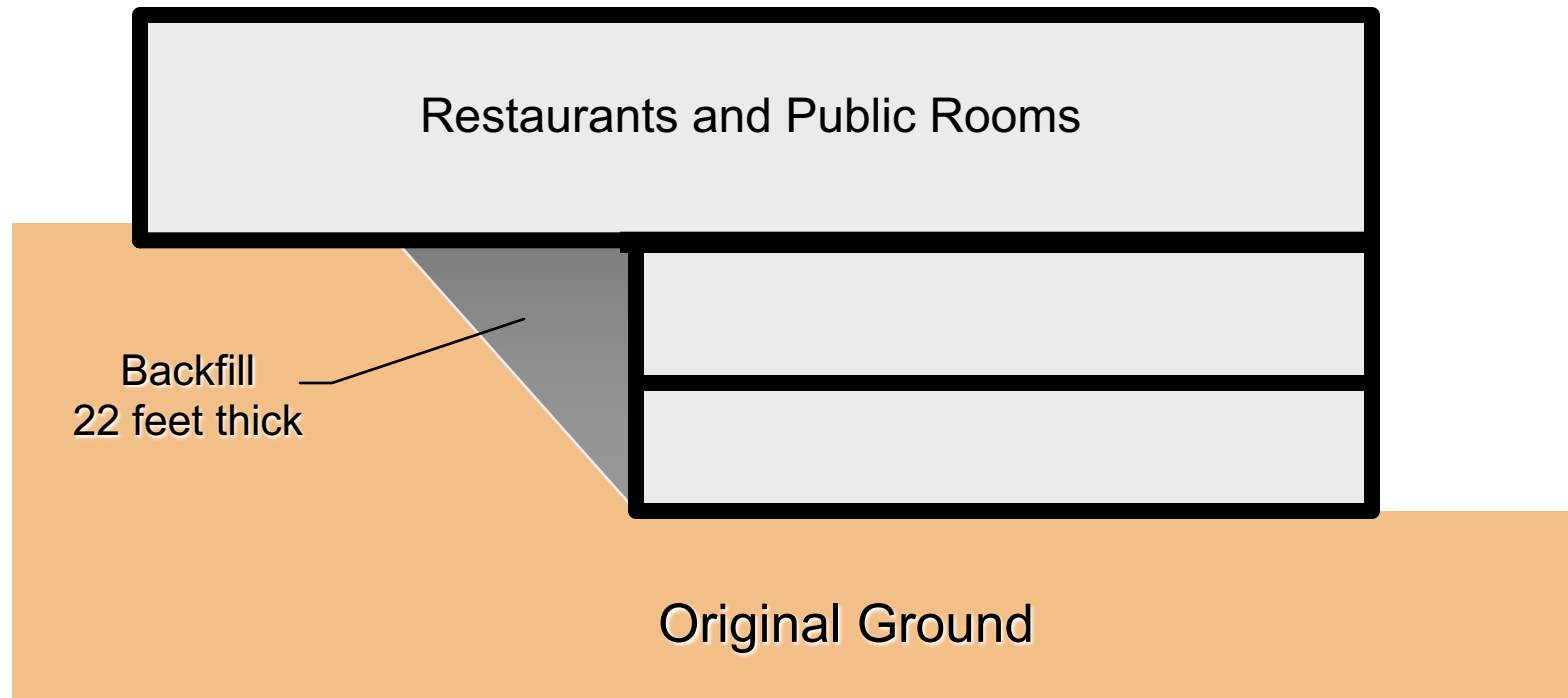
Cross-section through Hotel

- ▶ Initial hotel construction encountered ancient burial ground
- ▶ Hotel site was moved upslope
- ▶ Developer cut testing budget to offset cost over-runs

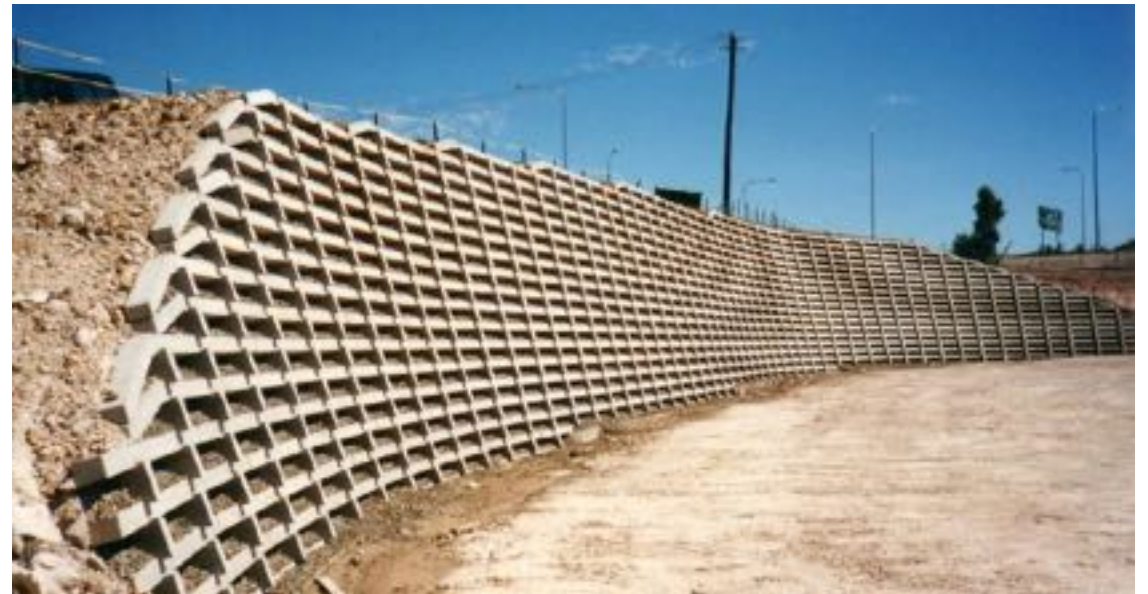
- ▶ Significant cuts and fills dictated use of retaining walls near property boundaries
- ▶ Crib wall selected due to low relative cost

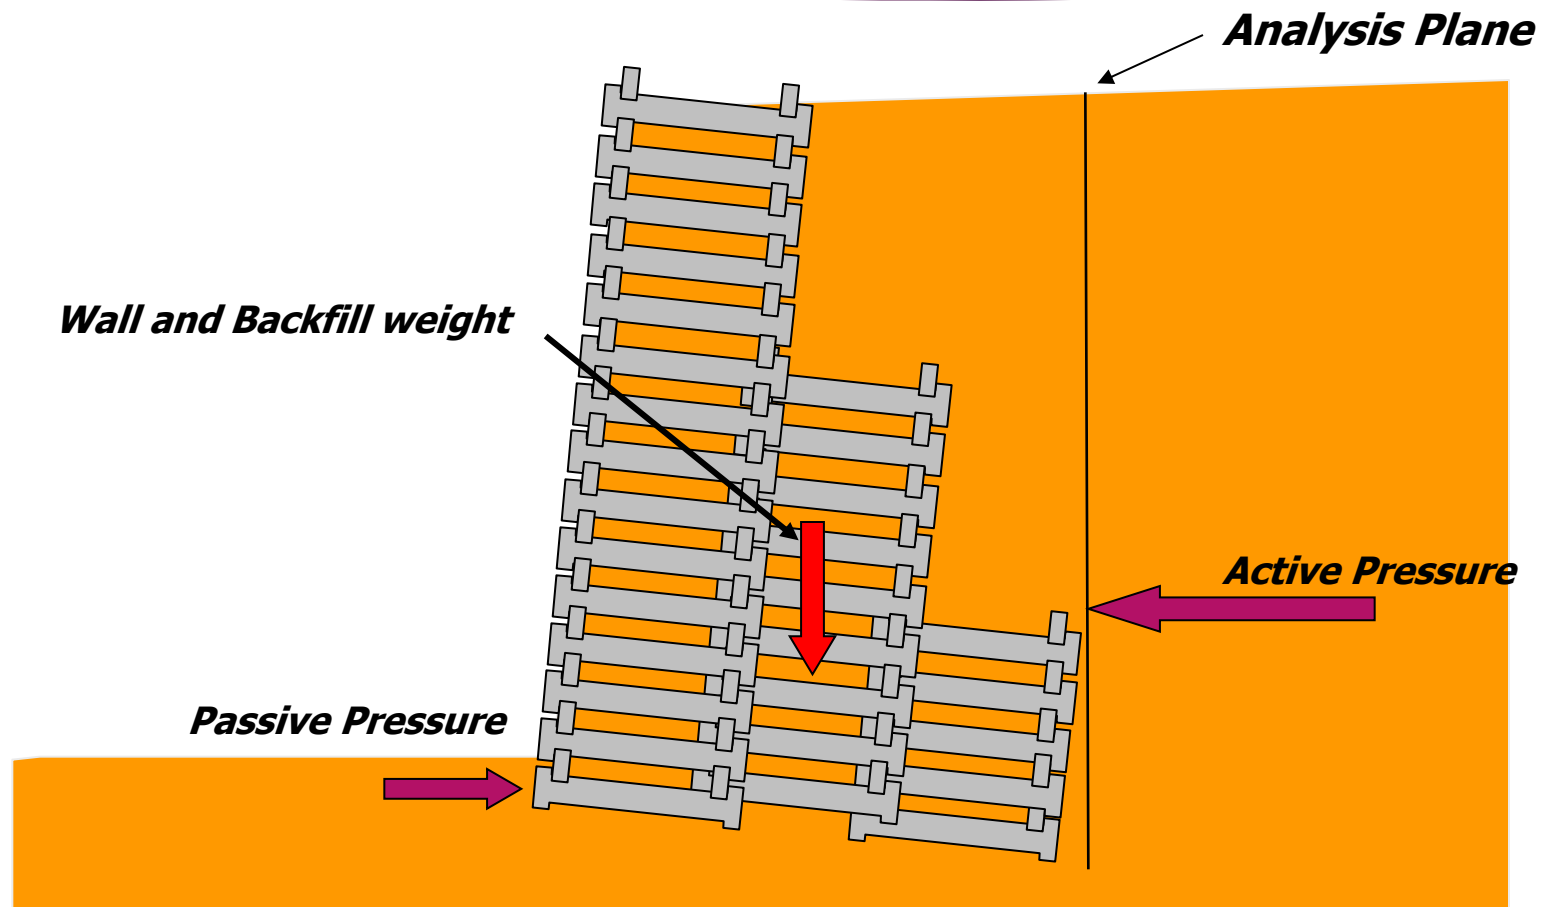
Stability Analysis

- ▶ Walls over 25 feet in height were found to settle differentially leading to a progressive failure over time.
- ▶ More massive walls were required to shift the resultant of pressures to the center of the wall base to avoid differential settlement.

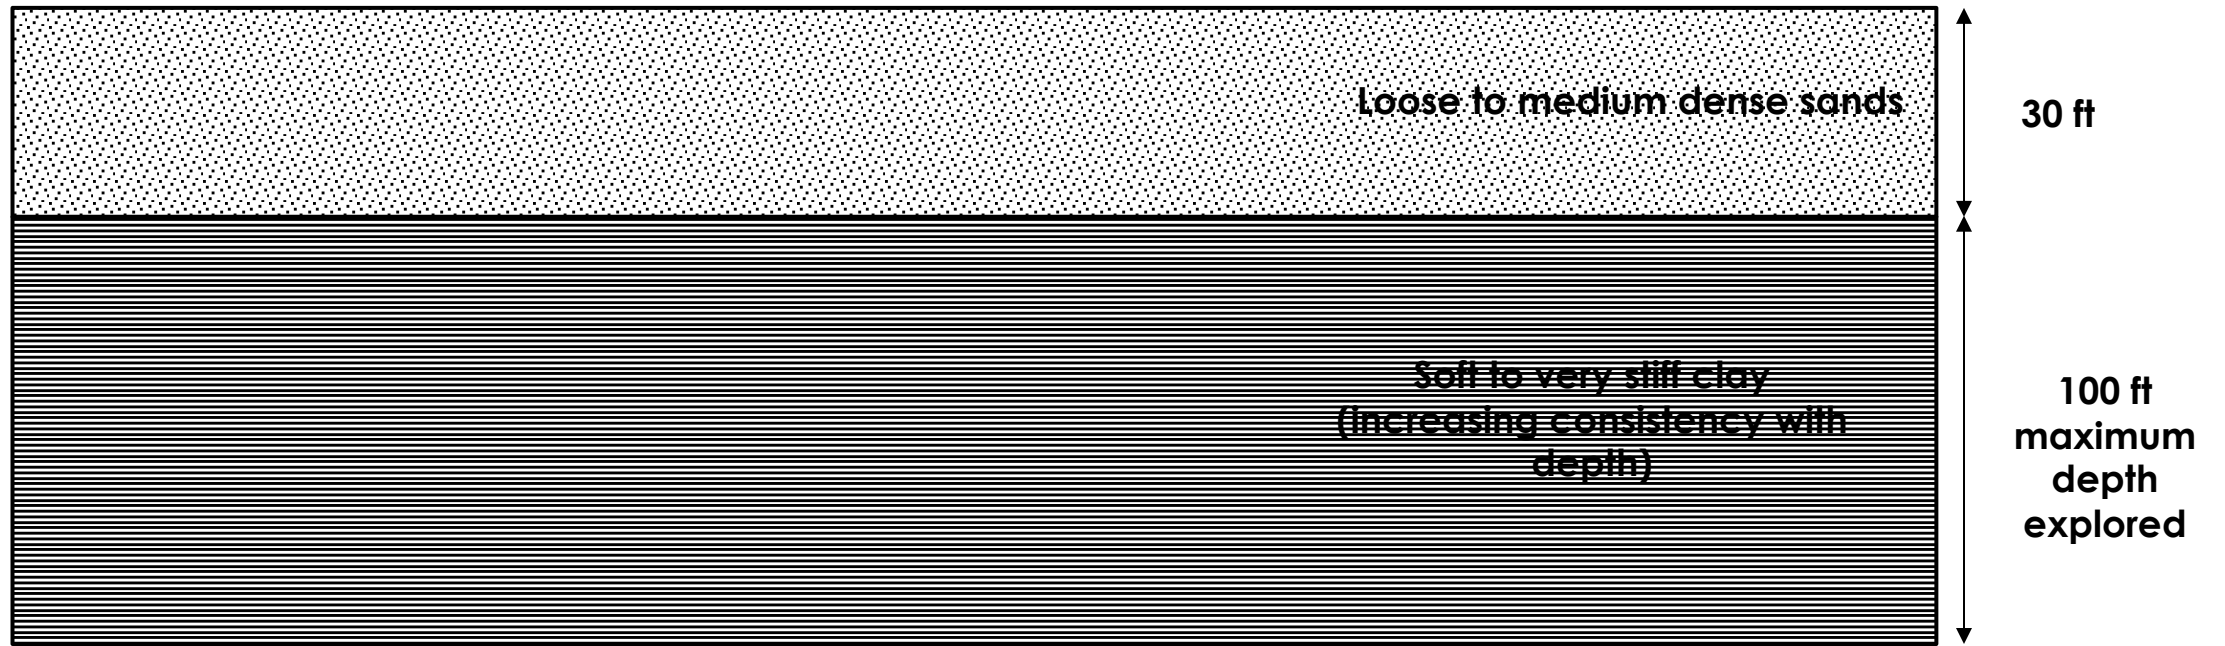
Subsurface Profile

- Blow counts in the test borings were not corrected for depth. What appeared to be 24 blow per foot material was closer to 10 blows per foot after correction.
- Design did not consider the group effects of 500 piles under the tower.
- The low and high-rise sections were structurally connected and experienced 16 inches of differential movement over 1 bay.
- While tower settled relatively uniformly, and was structurally sound, it could not be separated from the parking deck due to the post-tensioning cables.

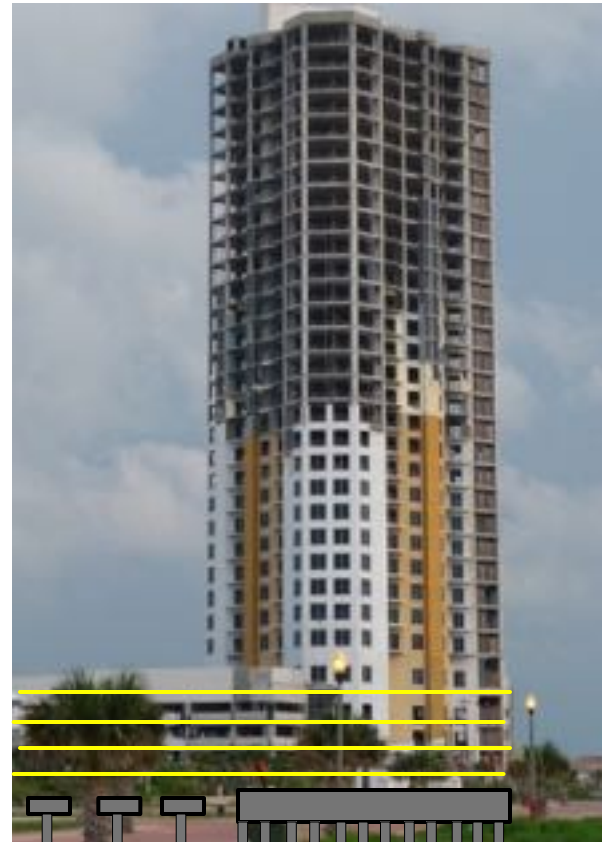
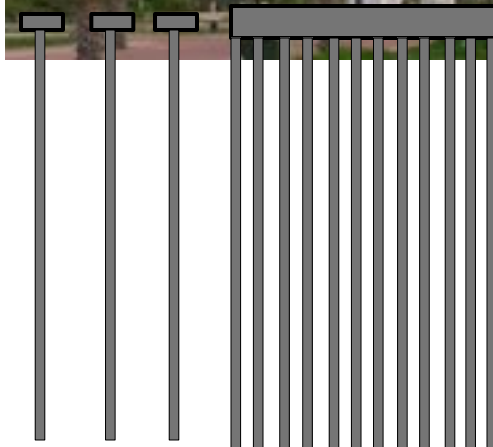
Structural Configuration

- Mat foundation supported by 100 foot long, 16 inch diameter augercast piles (125-ton capacity) under tower
- Pile caps supported by 16 inch diameter augercast piles in parking deck
- Structure post-tensioned

- ▶ Pile groups do not perform the same as individual piles – consider group effects
- ▶ Isolate high rise from low rise sections of buildings as they will experience different magnitudes of settlement

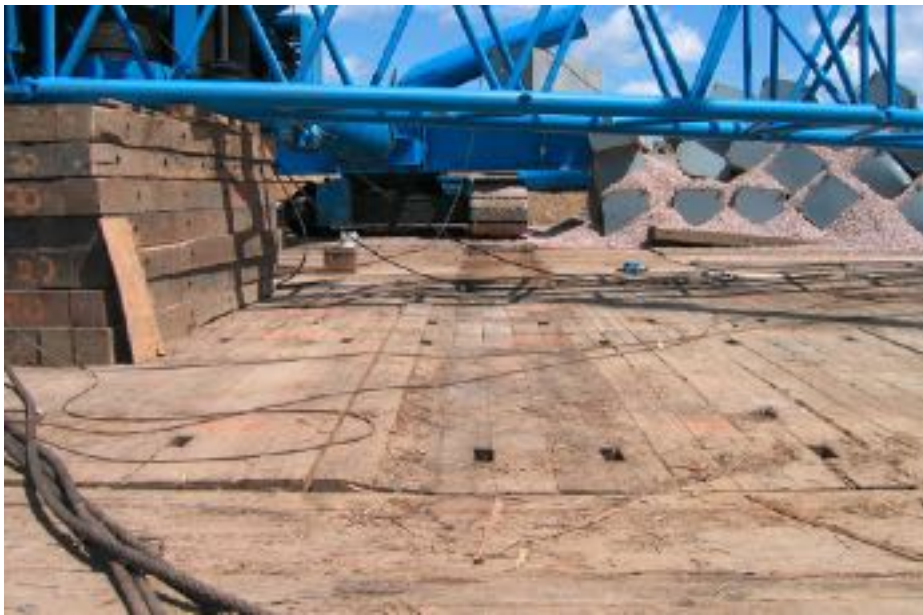
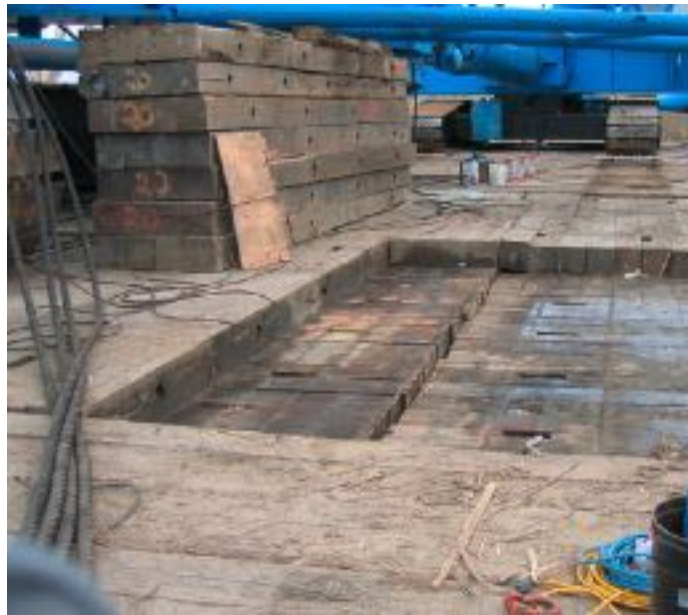
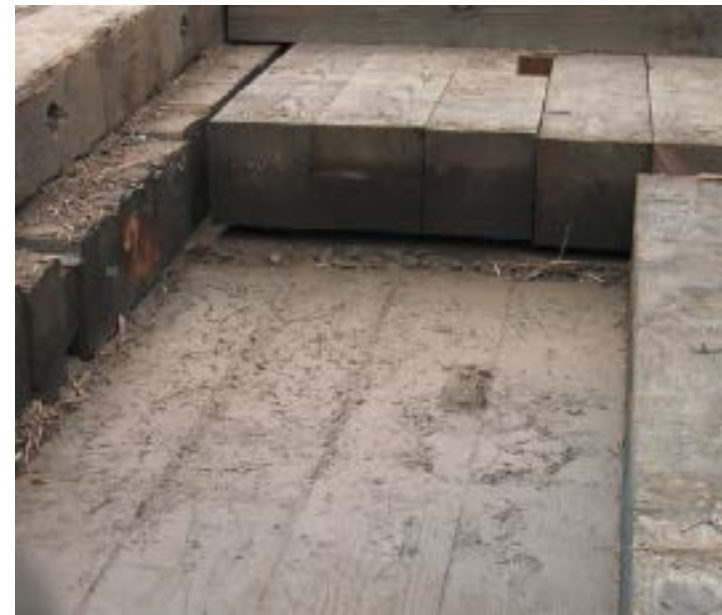
Timber Mat Settlement

- ▶ Mat placed on sandy silt soil – subgrade inspected by project geotechnical engineer and judged to be suitable
- ▶ Mat situated in low area between two sets of railroad tracks
- ▶ 4 inches of rain recorded in days leading up to failure – water ponded around timber matting

- ▶ Engineers should consider support capacities of soil under all environmental conditions
- ▶ Contractors should react to obvious and observable changes in conditions and should seek support from qualified engineers

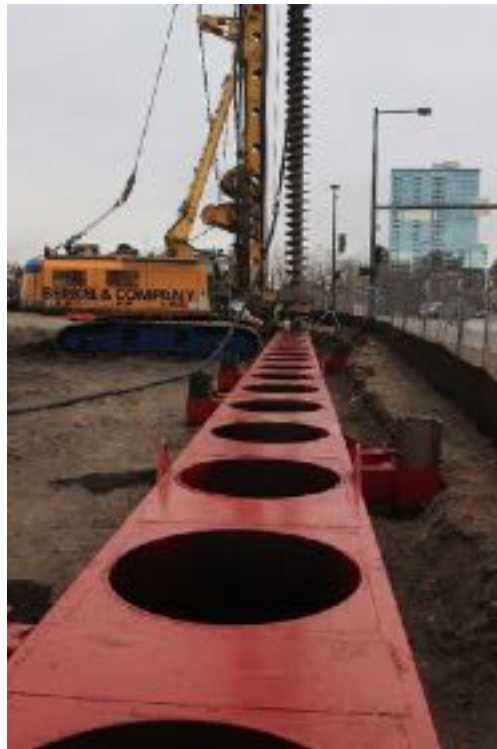
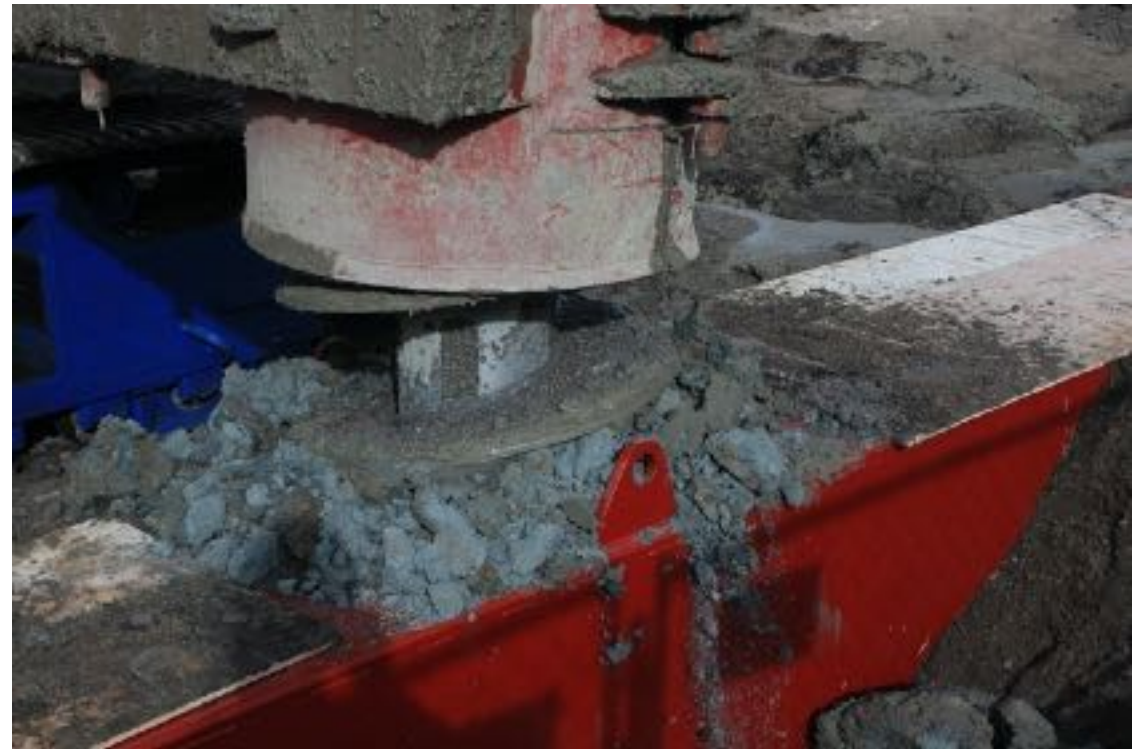
Secant Pile Walls

- ▶ Overlapping CFA piles 3 feet in diameter to create impervious barrier
- ▶ Socketed 5 feet into bedrock
